LOWER CONNECTICUT RIVER BASIN
BERLIN , CONNECTICUT

KENSINGTON DAM CT 00250

PHASE I INSPECTION REPORT
NATIONAL DAM INSPECTION PROGRAM

FEBRUARY 1979

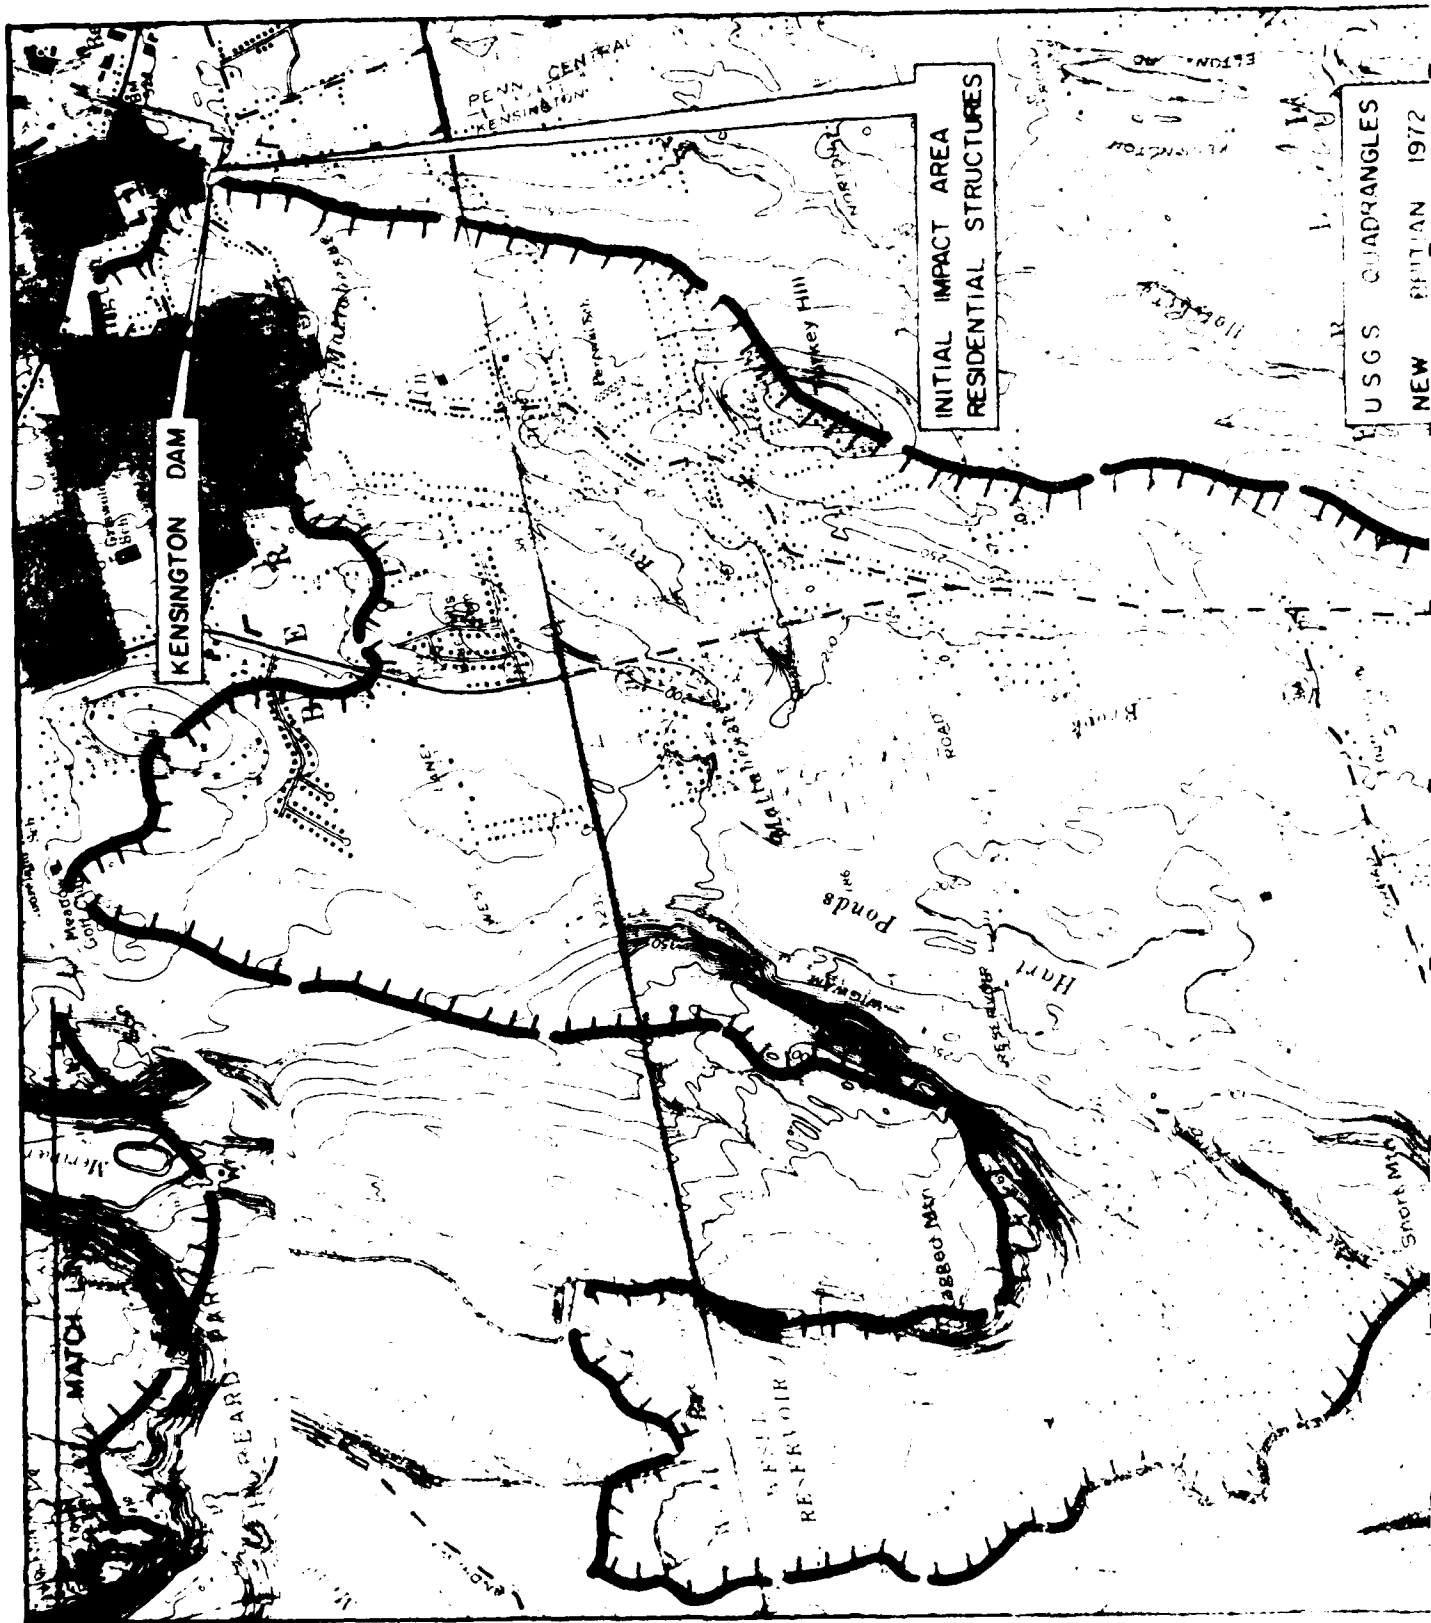
PLATE NO. 2
US ARMY ENGINEER DIV NEW ENGLAND
CANN ENGINEERS INC
WALLINGFORD, CONNECTICUT
ARCHITECT-ENGINEER
WALTHAM, MASS

DRAINAGE AREA
99 SQ. MI.
